Issued March 25, 1907.

OFFICE OF EXPERIMENT STATIONS—BULLETIN 179,

# SMALL RESERVOIRS

F. C. HERRMANN,

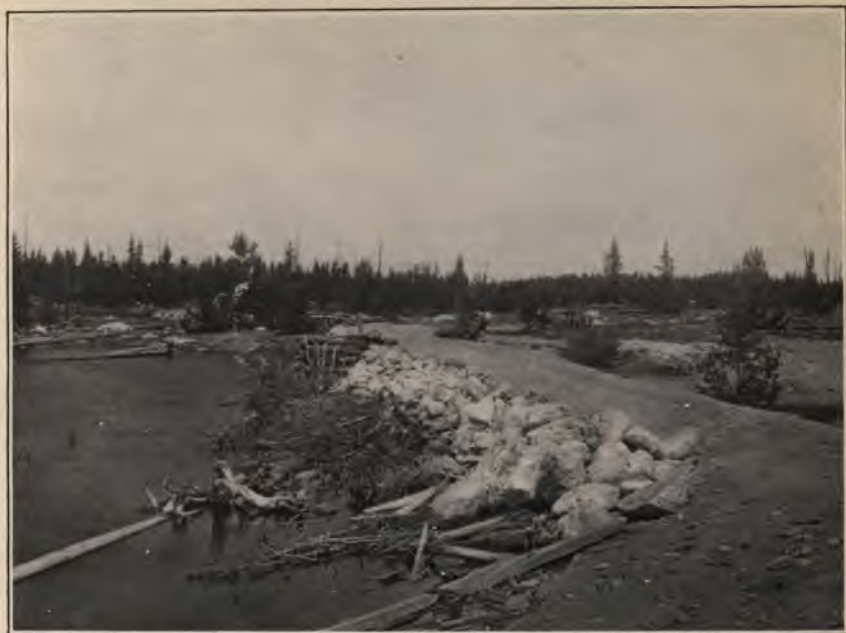
The outlets are ordinary 10-inch or 12-inch lap-welded pipes, provided with gates at the upper or inner ends. Each gate is operated by a wheel and a stem, which are protected from floating logs or stumps by a fender made of logs, as shown in Plate II, figure 1.

FIG. 1.—ONE OF THE COLORADO RESERVOIRS, SHOWING HOMEMADE GATE FENDER.

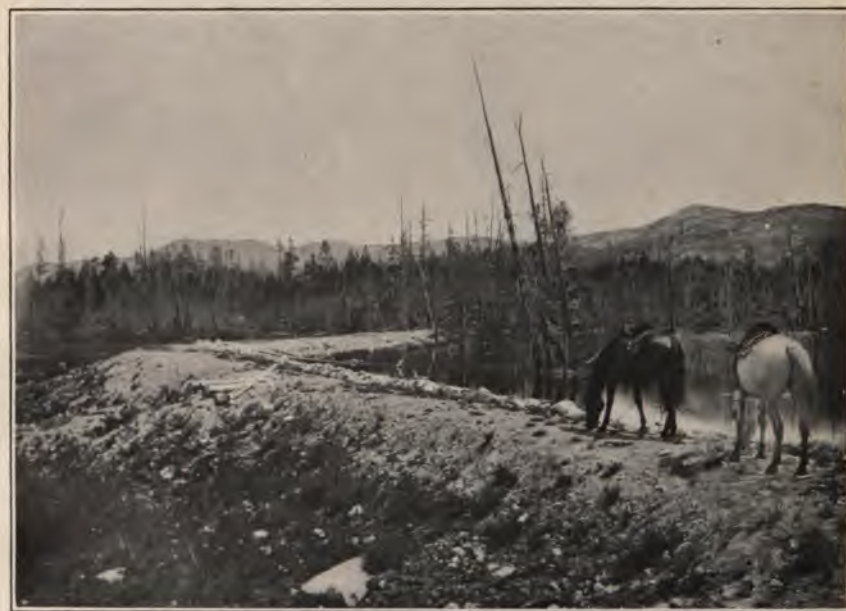
FIG. 2.—LAST CHANCE RESERVOIR DAM, SHOWING RIPRAPPING FOR WAVE PROTECTION.

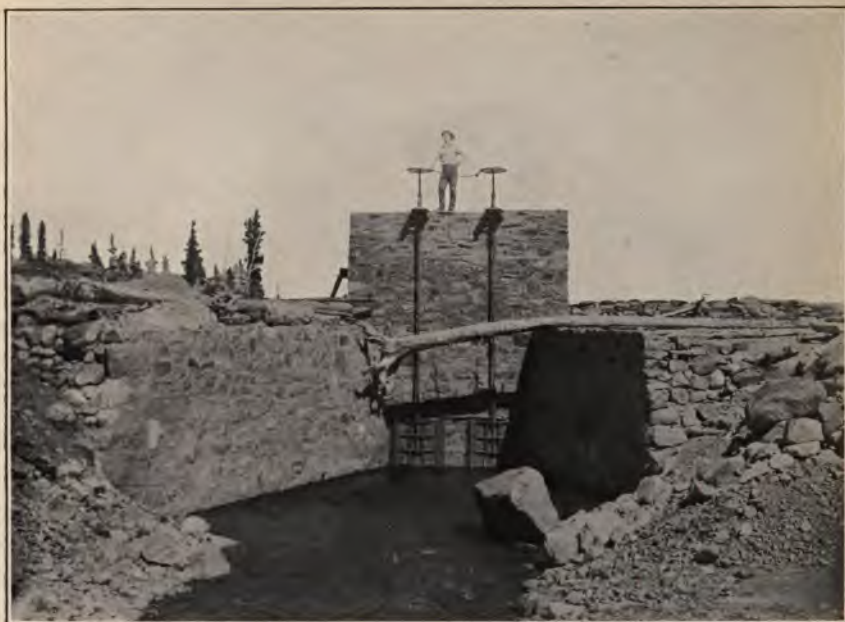
FIG. 1.—OUTLET OF CLOUDS PEAK RESERVOIR.

tection of the entrance to the gates, and a concrete well, by means of which the gates are operated. This gate with well and walls is shown in Plate III, figure 1. These gates, weighing several tons each, were taken from the railroad some 50 miles from the reservoir, and, on account of their weight and make, had to be hauled all the way intact, which precluded the use of pack animals. For the first 40 miles, or to the base of the Big Horn Mountains, no serious difficulties were encountered, but for the last 10 miles there was no road. By the use of a great many animals and ingenious methods for braking, these gates were hauled in a wagon over exceedingly steep mountains, through thick timber and brush, and over very rough gorges and canyons, the path taken being even now a difficult one for a man on horseback. The sacks of cement used in the concrete work were transported by pack animals at great expense. On account of the shortness of the working season, and the difficulty for men to work at such a high altitude, progress has not been rapid, though by the fall of 1905 the outlet was complete and the foundation of the dam was partially cleared. It was the intention to install derricks and a cableway as soon as the season of 1906 opened, and to carry on the remaining work with all possible speed.

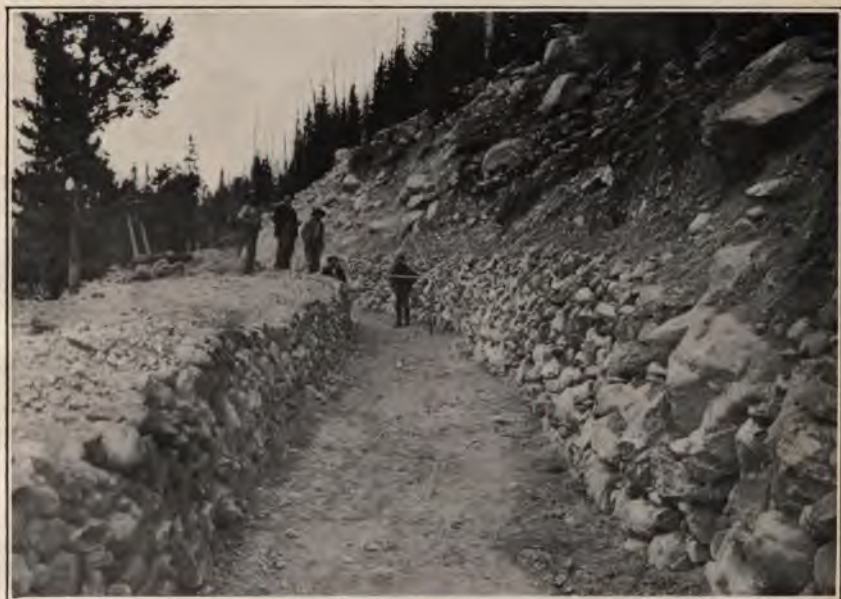
FIG. 2.—SECTION OF OUTLET DITCH OF CLOUDS PEAK RESERVOIR, SHOWING LINING OF DRY STONE WALL.

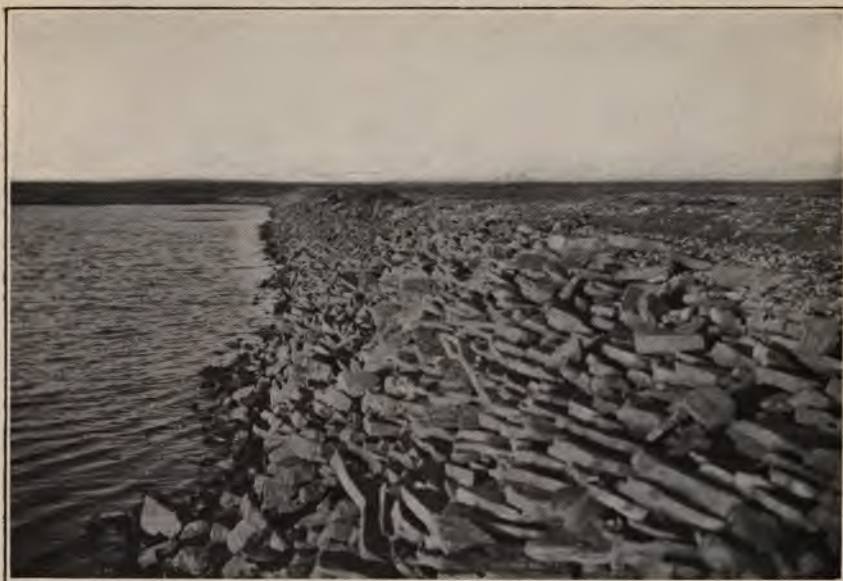
FIG. 1.—TISDALE RESERVOIR, NORTHWEST OF CASPER, WYO., SHOWING ACTION OF WAVES ON PITCHING.

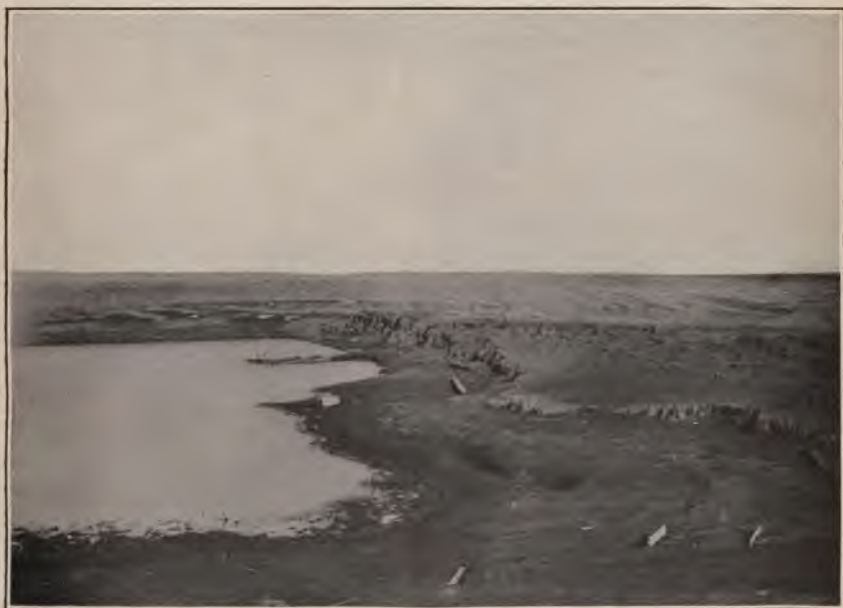
FIG. 2.—RIPRAP ON DAM OF CASPER CREEK RESERVOIR, 12 MILES WEST OF CASPER, WYO.

it was decided that it was necessary to have a mat underlying the stone pitching, and, as sagebrush is very plentiful throughout the plains, it was decided to try a combination of sagebrush mat and rock pitching. About this time the dam of the Casper Creek Reservoir went out for the second time, the first failure being due to wave action and the second to the underground work of groundhogs. In repairing this dam (Pl. IV, fig. 2) the water slope was covered with stone pitching on a sagebrush mat. The work, which was carefully done a few years ago, at a cost of about one-half the original cost of the entire dam, was satisfactory until the underlying sagebrush began to rot. This allowed some of the stones to settle sufficiently to break the continuity of the surface, leaving a weak spot for the waves to attack. At the time of inspection the stone surface was showing signs of failing, and, as this dam has a maximum exposure to the prevailing wind, repairs will soon be necessary in order to prevent another rupture. It is seen from this that the two trials of rock pitching have been very expensive and not a complete success.

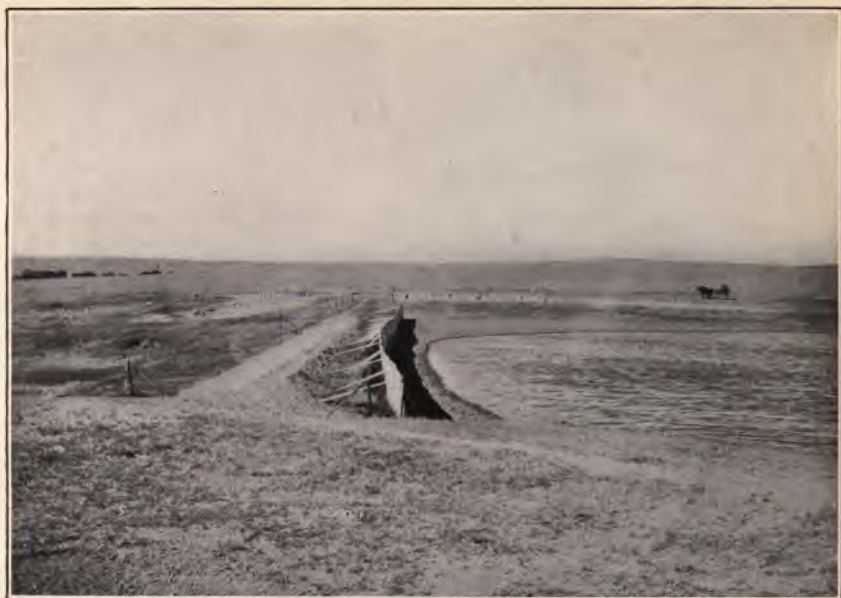
FIG. 1.—WAVE FENCE WITH LONG BRACES.

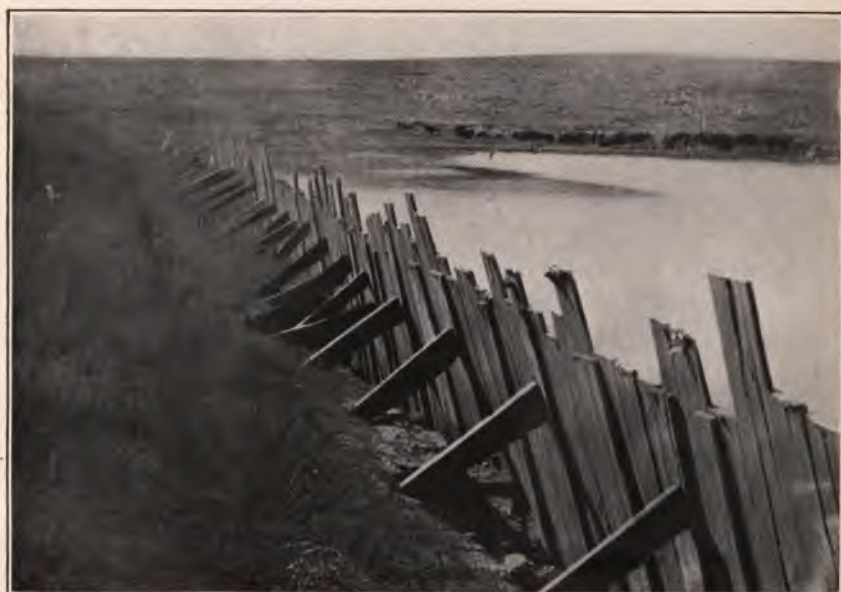
FIG. 2.—WAVE FENCE WITH SHORT BRACES.

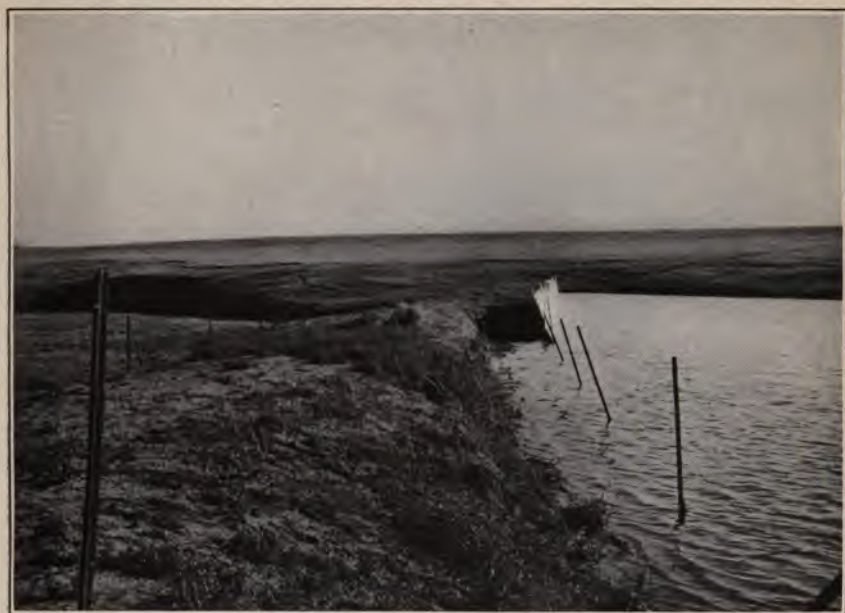
FIG. 1.—NEW BULL CREEK RESERVOIR, SHOWING EROSION WHERE FENCE HAS BEEN STOLEN BY CAMPERS.

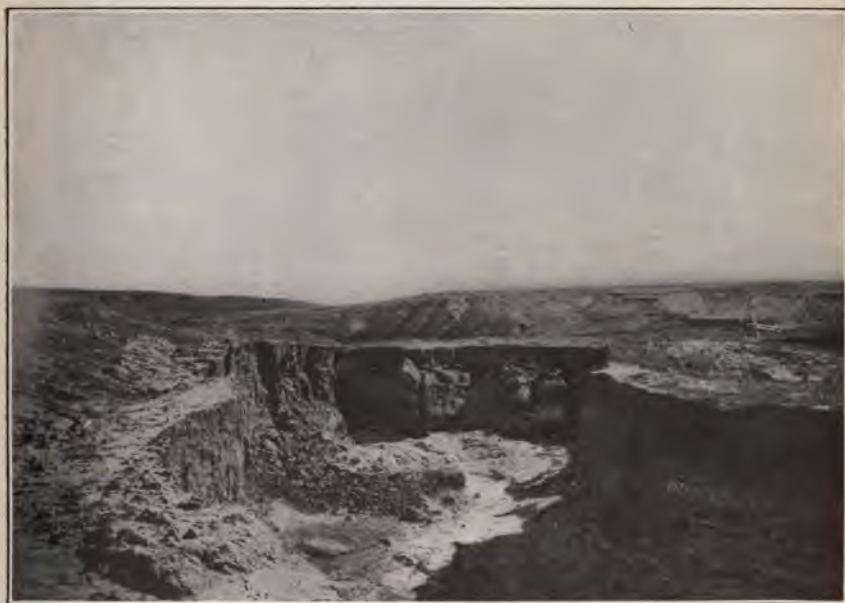
FIG. 2.—EROSION OF WASTEWAY OF CROW RESERVOIR, NORTH OF BELLEFOURCHE, S. DAK.

Although the sizes of the wasteways have always been sufficient, erosion of wasteways has given no end of trouble, and their maintenance against this danger has become a problem nearly, if not quite, as important as the silt problem. The cause of the trouble is that, as a rule, where artificial wasteways are constructed, and sometimes when natural ones are used, there is too much fall between the point where the water leaves the reservoir and the point where it enters some water course. For this reason there is usually formed a fall at the latter point which constantly recedes from the natural water course and approaches nearer and nearer the reservoir. As the fall recedes it increases in height and in power to do harm. Eventually it will reach the reservoir and, of course, ruin its storage

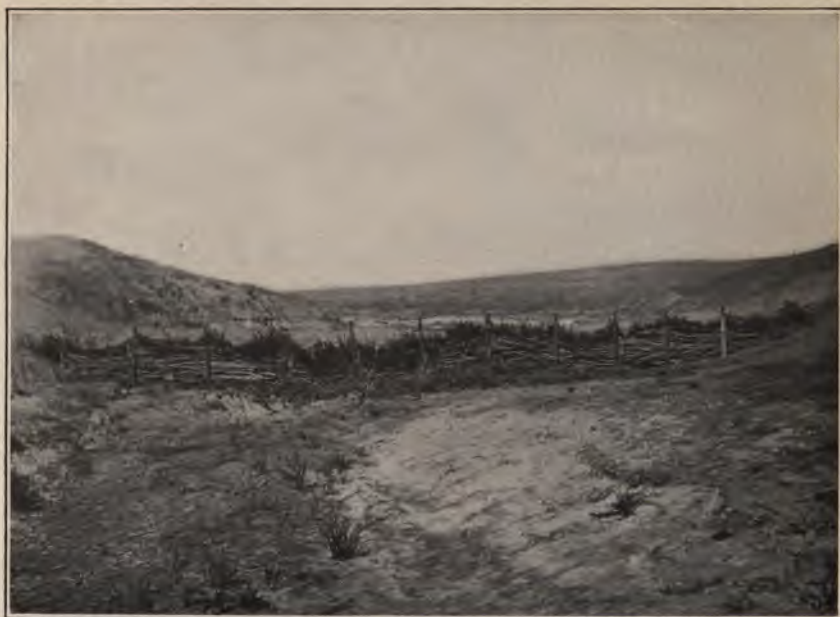
FIG. 1.—BRUSH CHECK IN THE WASTEWAY OF BOX ELDER RESERVOIR.

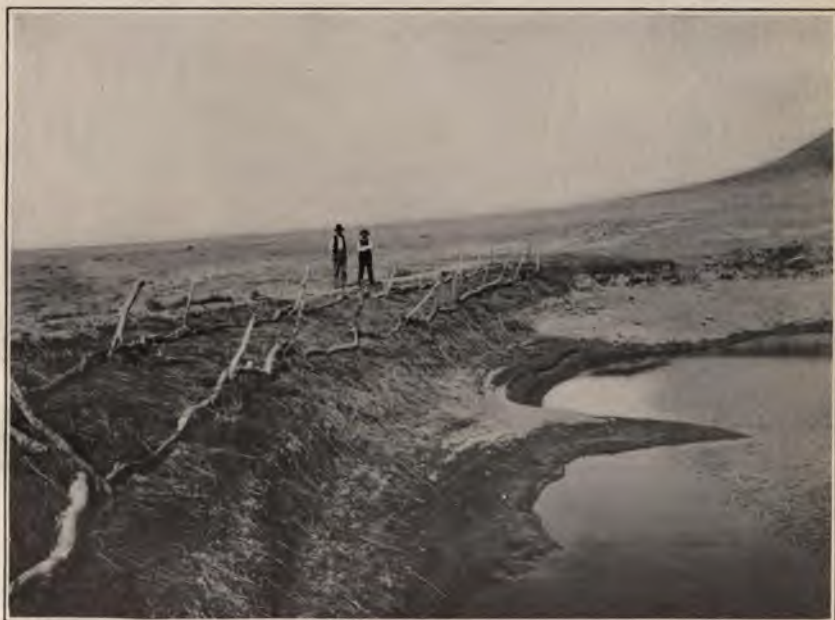
FIG. 2.—BRUSH PROTECTION FROM WAVES ON DAM OF HARRIS RESERVOIR NO. 2, ON TRAIL CREEK, MONTANA.

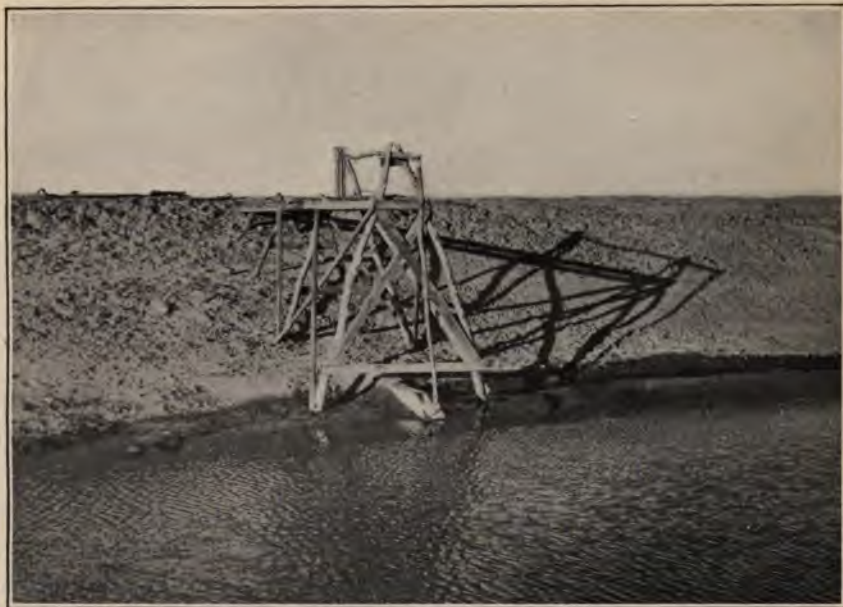
FIG. 1.—OUTLET OF HARRIS RESERVOIR NO. 1.

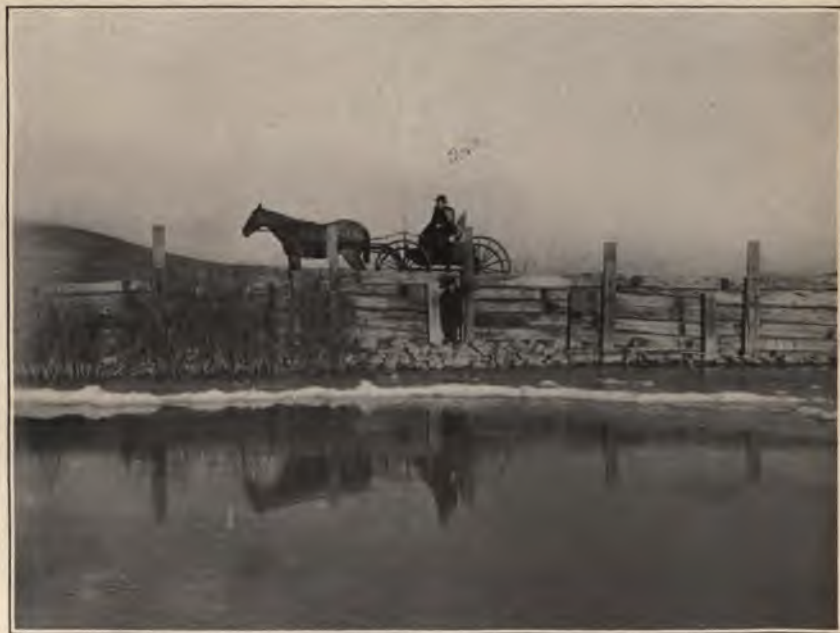
FIG. 2.—GRIFFIN RESERVOIR, 6 MILES WEST OF CHEYENNE, WYO., SHOWING REVETMENT.
